**CONSTRUCTION ENGINEERING GEOTECHNICAL
REPORT FOR IMPACT MINISTRY BUILDING
INFRASTRUCTURES IN JOHANNESBURG, SOUTH
AFRICA.**

Client: IMPACT MINISTRY

Report No.: 103-01-11 July 2011

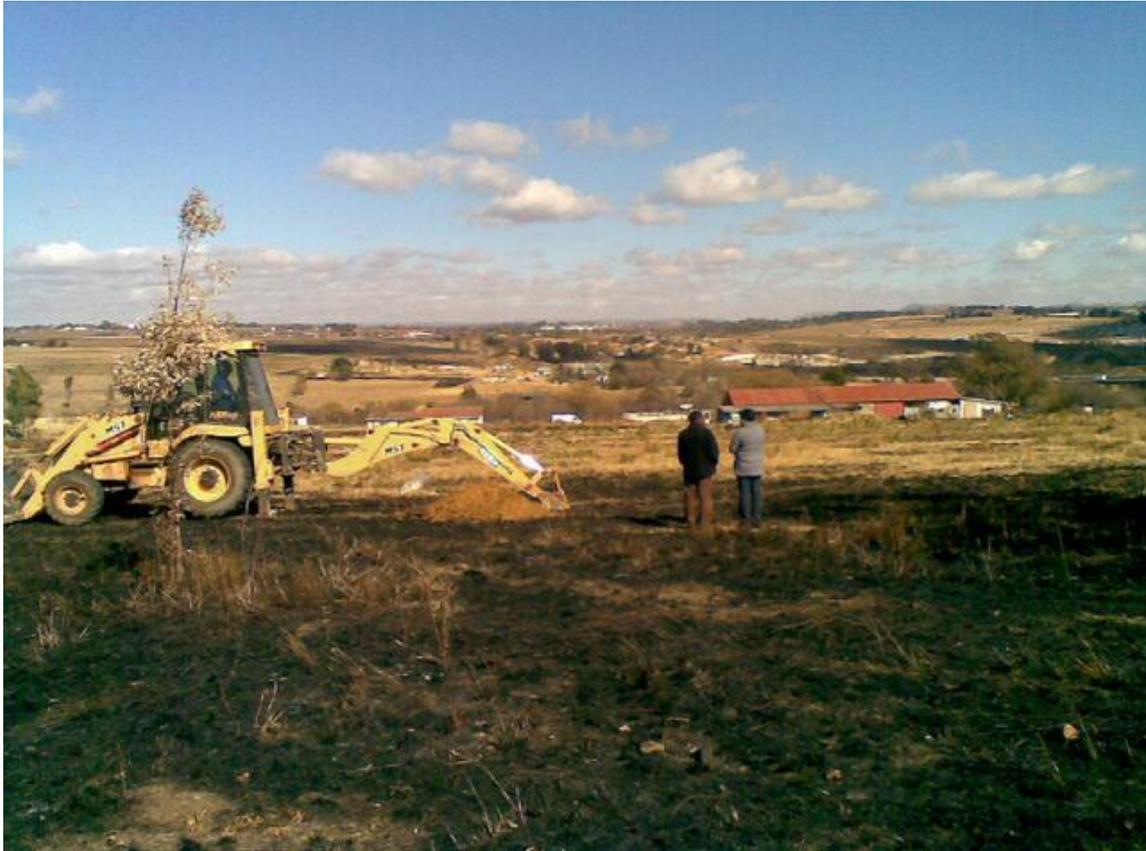
Vegetation on site was composed of short well established grass and weeds. (see plate 1)

Plate 1: Vegetation on site where the Dome will be built.

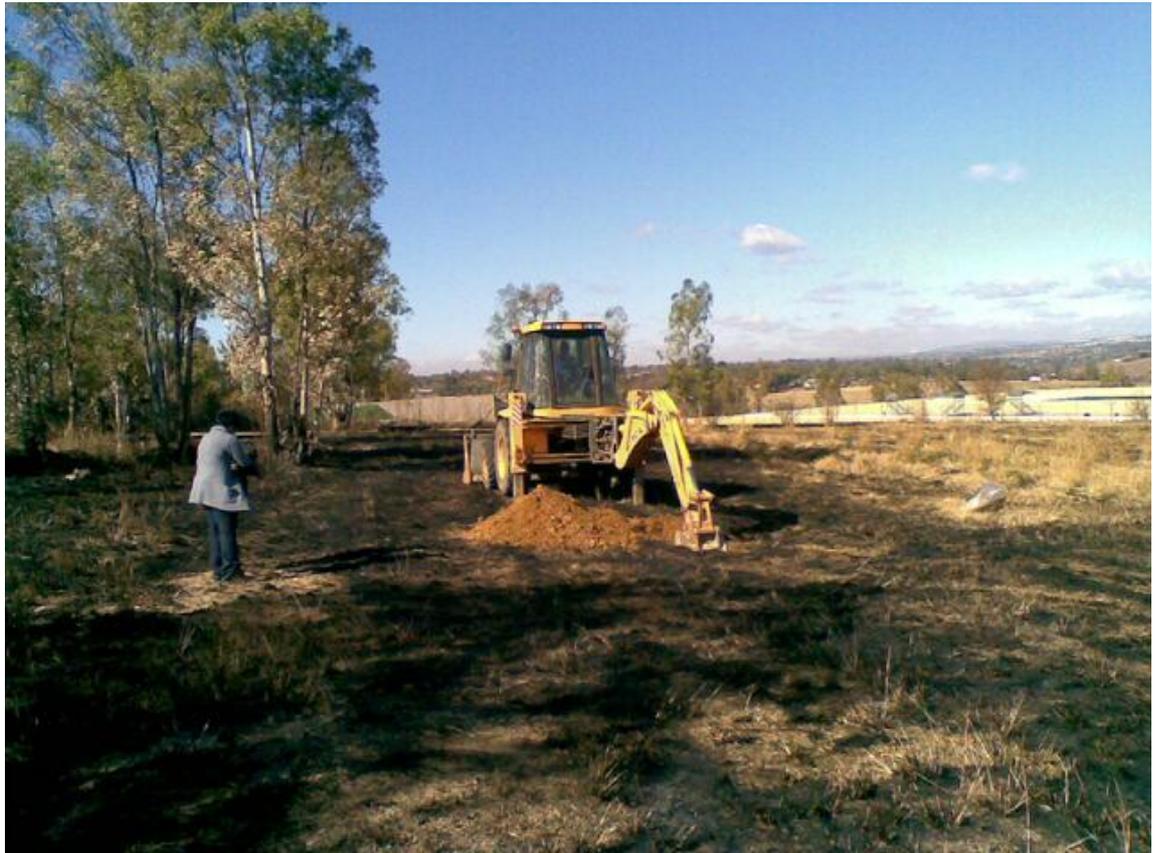
Plate 2: Test pit excavation on the area where Dome structure will be built.

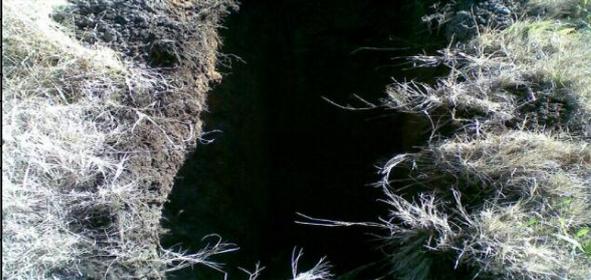
PROJECT: Impact village	TEST PIT: TP4	DATE: 2011 July
SITE: Impact ministry site (JHB)	LOGGED BY: Mashudu Shandukani	
CLIENT: Impact ministry	COORDINATES: 24°56'57.32"S 27°57'45.4"E 1337m	
	MACHINE: TLB CAT

Depth (cm)	Legend	SOIL PROFILE	Sample
10	[Dotted pattern]	Moist to wet, black, soft to firm, intact, silty Clay with Ferricrete nodules of Quartzite, Colluvial.	
20			
30			
40			
50			
60			
70			
80			
90			
100			
110			
120			
130			
140			
150			
160			
170			
180			
190			
200			
210	[Dotted pattern]	Whitish, moderately to slightly weathered, medium jointing, medium grained, hard rock. Quartzite	
220			
230			
240			
250			
260			
270			
280			
290			
300	[Symbol: ط]		
310			
320			
330			
		Notes: Machine refusal at 2.7m. No water seepage observed.

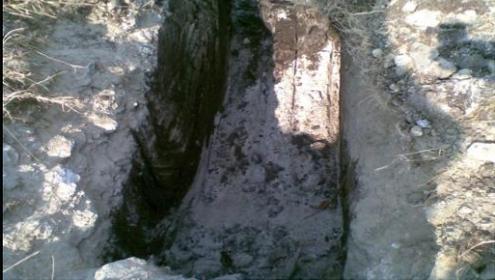
Depth (cm)	Legend	SOIL PROFILE	Sample
10	•••••	Dry, Brown, dense, silty Fine sand.colluvium.	
20			
30	▣		
40	▣	Slightly moist to moist, whitish brown, dense, intact, sandy GRAVEL, Residual Quartzitic sandstone	
50	▣		
60	▣	Whitish, moderately to slightly weathered, medium jointing, medium grained, hard rock. Quartzite	
70	▣		
80	ط		
90			
100			
110			
120			
130			
140			
150			
160			
170			
180			
190			
200			
210			
220			
230			
240			
250			
260			
270			
280			
290			
300			
310			
320			
330			
340			
350

Notes:
Machine refusal at 0.7m. No water seepage observed.
