# HYDROPEDOLOGICAL STUDY

PORTION 72 OF THE FARM BULTFONTEIN 533JQ, LANSERIA GAUTENG

INDEX (PTY) LTD

August 2024

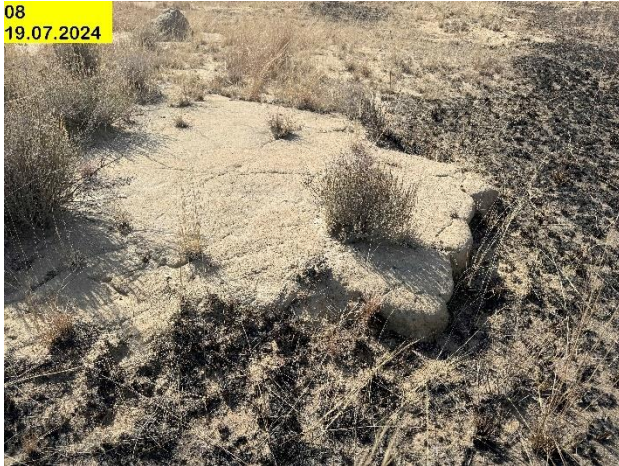
**Profile 8**

Orthic A horizon

Hard rock

Classification: Mispah / Rock outcrops

Dry, with no signs of wetness. Drainage occurs as surface flow as soon as the topsoil is water saturated.

The profile makes no contribution to the base flow of the watercourse.

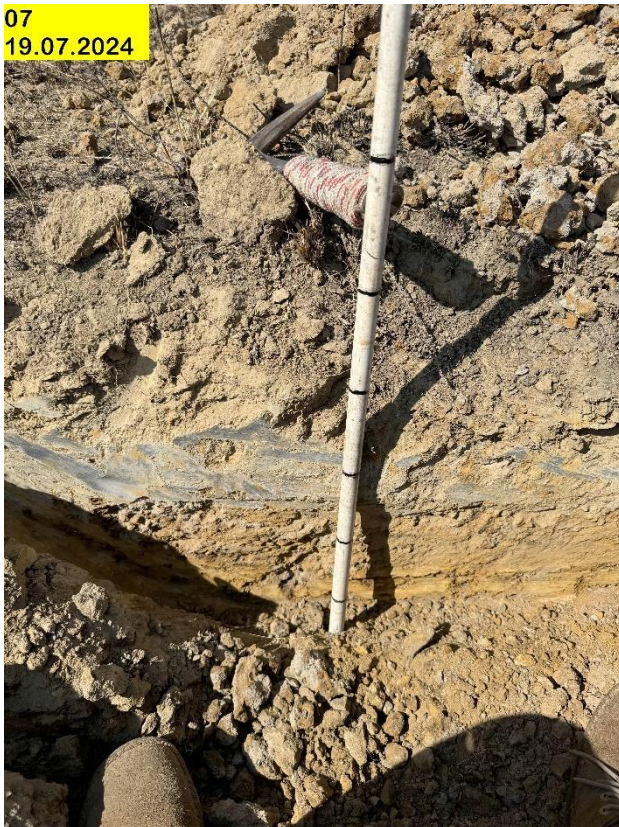
**Profile 7**

Orthic A horizon

Lithocutanic B

The lower subsoil is greyish brown with gleyed properties.

Classification: Glenrosa

Dry, with slight signs of wetness in the deeper subsoil. It is free of bleached layers. Drainage occurs as surface flow once the topsoil is water saturated.

The profile makes no contribution to the base flow of the watercourse.

Classified as Deep Interflow soil.

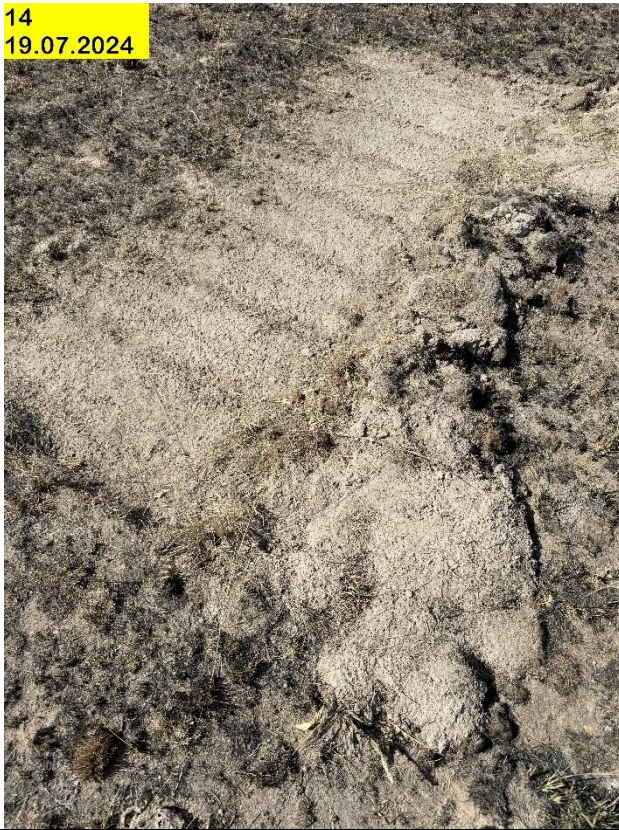
**Profile 14**

Orthic A horizon

Hard Rock

All the soil up the hard rock layer has been removed.

There is no soil present.

Classification: Mispah

Dry, with no signs of wetness. Drainage occurs as surface flow.

The profile makes no contribution to the base flow of the watercourse.

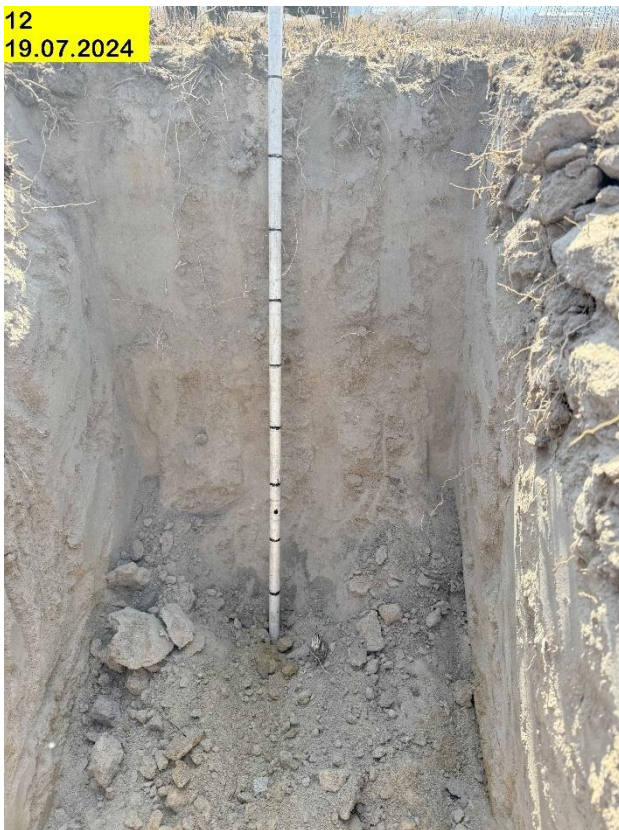
**Profile 12**

Occurs in the drainage basin outside of the subject site.

Orthic A horizon

Lithocutanic B

Classification: Glenrosa or Oakleaf.

The soil colour is light grey with a sandy loam structure. Although the soil profile is dry, there are signs of at least temporary saturated conditions. The B and C horizons are gleyed

Dry, with no signs of wetness. Drainage occurs as surface flow with small volumes that may drain laterally when the soil is water saturated for prolonged period.

The profile makes little contribution to the base flow of the watercourse.

Classified as Deep Interflow soil.

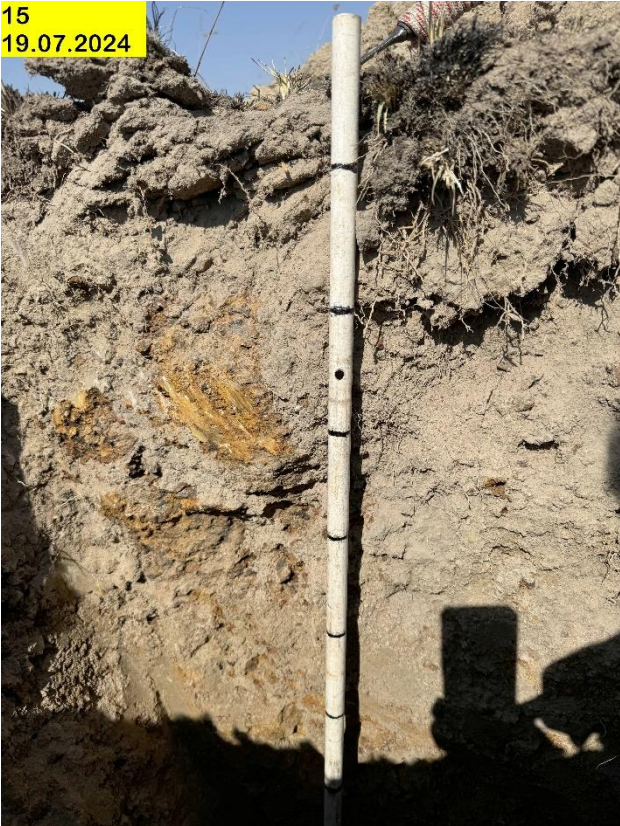
<p>15 19.07.2024</p>

<p><b>Profile 15</b>          Orthic A horizon          Lithocutanic B / Soft plinthite / G          Classification: Glenrosa / Longlands / Avalon</p> <p>Slightly moist, with no signs of a permanent perched water table. It is free of bleached layers that would indicate significant lateral subsurface water flow.          The profile occurs in a depression created where the topsoil was removed.</p> <p>The profile makes no contribution to the base flow of the watercourse – the water is lost through evaporation.</p> <p>Classified as Recharge soil.</p>
--------------------------	--	---

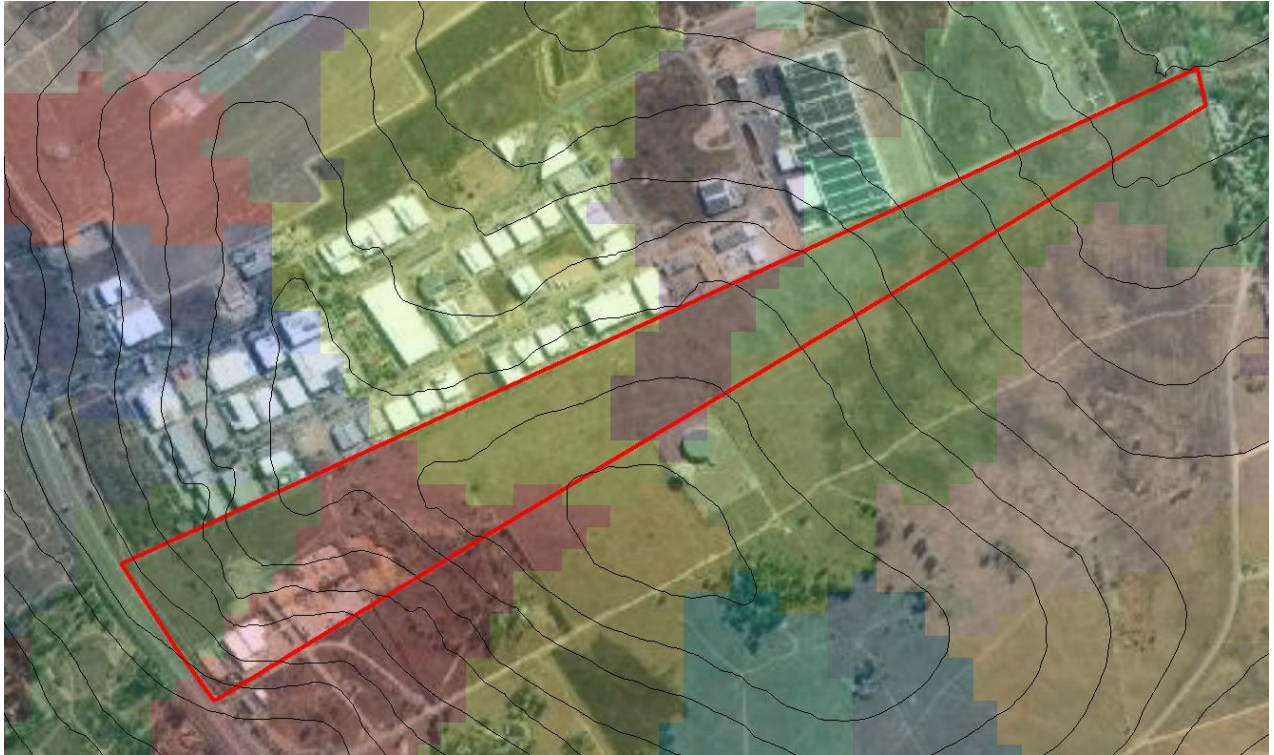
*Figure 7. Map indicating drainage areas and the industrial area to the north-west*

The site occurs on the crest of the landscape. Construction of the industrial area has modified the groundwater profile with the result that the only contribution that this site makes to the baseflow of groundwater is generated on the site itself.

The land is very uneven with many small excavations. This is the result of previous mining activities, likely from sand and gravel borrowing when the platforms for the adjoining industrial area were built. Much of the northern section is shallow soil that also lost its topsoil through mining.

The uneven previously mined area should be rehabilitated and levelled out to prevent pockets of water saturated soils, which could potentially damage the foundations of small structures.
