addendum 1

PROJECT No: A23/2057 Rev 1 13 March 2024

REPORT ON A GEOTECHNICAL INVESTIGATION CARRIED OUT FOR TOWNSHIP ESTABLISHMEN PURPOSES ON: PORTION 268 OF THE FARM RIETFONTEIN 189-IQ, GAUTENG PROVINCE

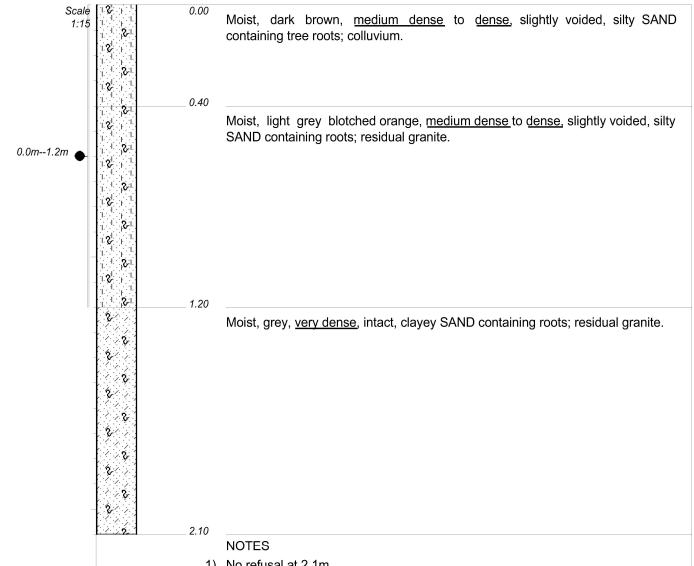
HOLE No: RF/01 Sheet 1 of 1

- 1) No refusal at 2,1m.
- 2) No water seepage encountered.
- 3) Disturbed bulk sample taken from 0,0m--1,2m.

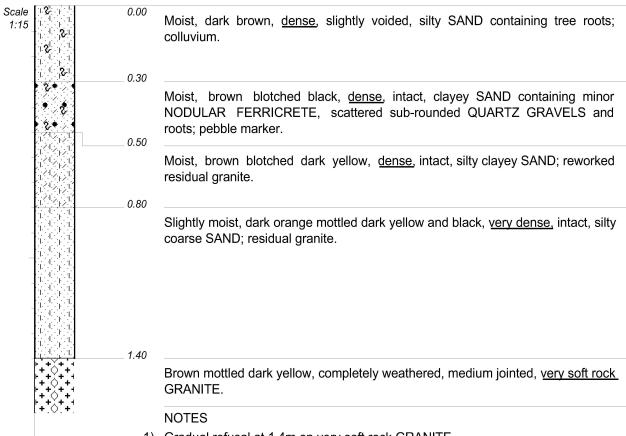
HOLE No: RF/05 Sheet 1 of 1

- 1) Gradual refusal at 1,4m on very soft rock GRANITE.
- 2) No water seepage encountered.

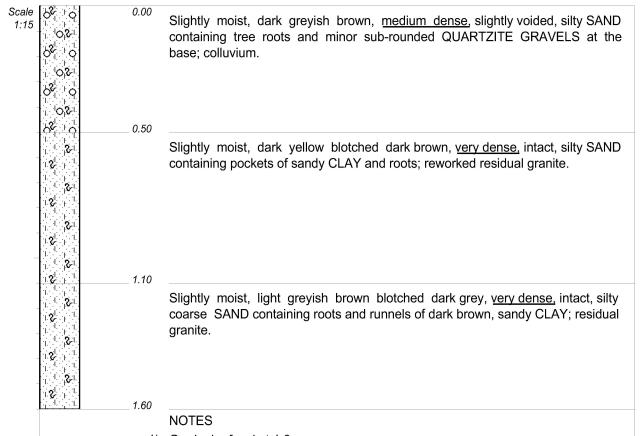
HOLE No: RF/07 Sheet 1 of 1

- 1) Gradual refusal at 1,6m.
- 2) No water seepage encountered.

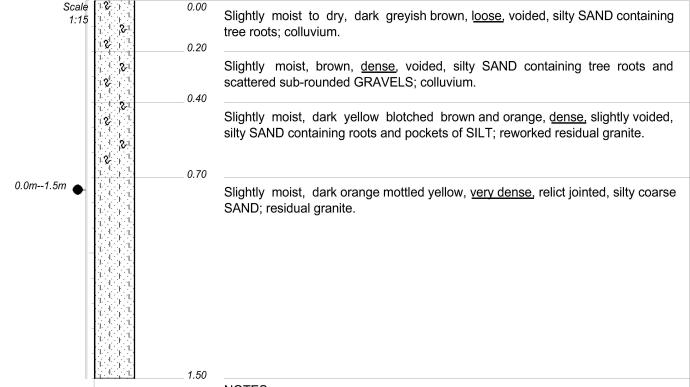
HOLE No: RF/10 Sheet 1 of 1

- 1) Gradual refusal at 1,5m in very dense residual granite.
- 2) No water seepage encountered.
- 3) Disturbed bulk sample taken from 0,0m--1,5m.

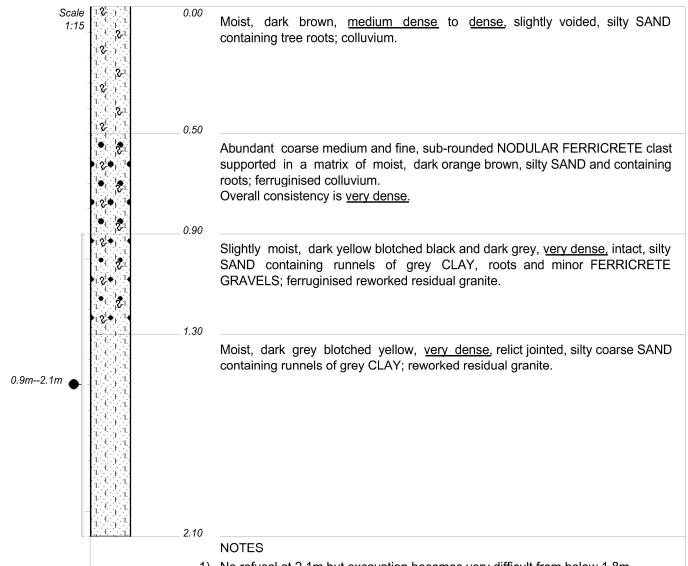
- 1) No refusal at 2,1m but excavation becomes very difficult from below 1,8m.
- 2) No water seepage encountered.
- 3) Disturbed foundation indicator sample taken from 0,9m--2,1m.
- 4) A stream occurs 25m north of the test pit.

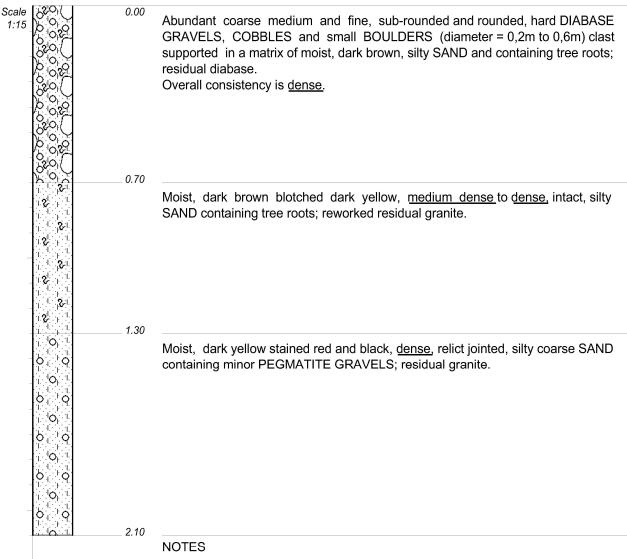
HOLE No: RF/17 Sheet 1 of 1

- 1) No refusal at 2,1m.
- 2) No water seepage encountered.
- 3) A north to south striking diabase occurs immediately east of the test pit.

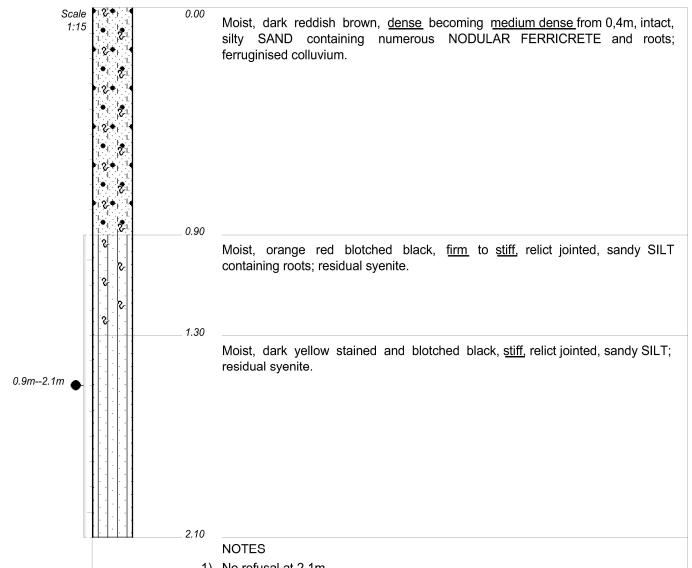
- 1) No refusal at 2,1m.
- 2) No water seepage encountered.
- 3) Disturbed foundation indicator sample taken from 0,9m--2,1m.
