Lanseria Extension 81 (Ptn of Ptn 2 of the Farm Bultfontein 533-IQ)

GEOTECHNICAL INVESTIGATION REPORT

REPORT NO: GGE/24009

June 2024

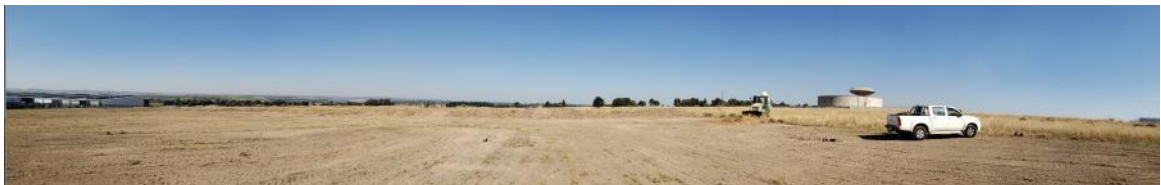
View of eastern slope - which is largely featureless grassland without any outcrop

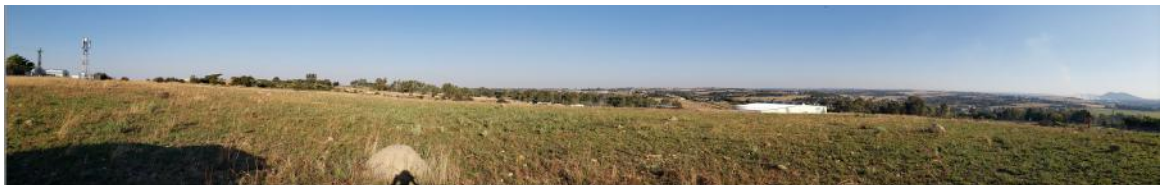
View of western slope - with evidence of scattered boulders at ground surface

In addition to the prominent outcropping ridge exposed on Erven 971 / 972, sporadic boulder/rock outcrop is littered throughout the surface of much of the lower half of the western slope of the site.

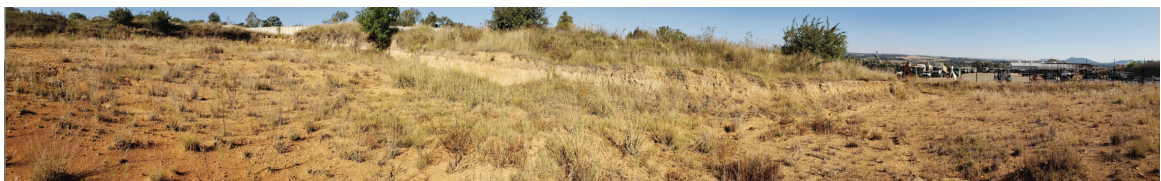
View of quarry on Erf 973, exposing bouldery residual diabase throughout most of the perimeter, with granite outcrop in the south-west

- (a) a small quarry on Erf 973 (see Figure 4 - Appendix A),
- (b) loose stockpiles of spoils - possibly derived from the quarry - which are predominantly placed on the adjacent Erf 972, but spill over onto Erf 971, 978 and 959 (see Figure 4 - Appendix A).

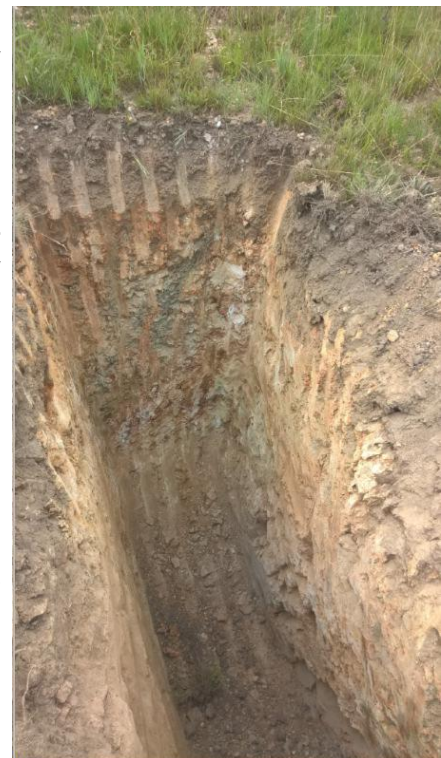
- (i) **Hillwash**
Dry to slightly moist, brown, medium dense, porous, silty sand.
- (ii) **Pebble Marker**
Dry though moist, reddish-orange blotched brown, medium dense, porous, silty sand, with abundant sub-rounded quartz gravels and cobbles becoming highly ferruginous in an easterly direction.
- (iii) **Variably Altered Reworked Residual Granite**
Slightly moist, reddish-orange blotched dusky-red and brown, medium dense, porous, clayey sand, with intermittent quartz veins
- (iv) **Residual Granite**
Slightly moist, olive-green through pale orange, pale yellow or dusky-red, medium dense to dense, intact and relict-structured, silty sand.

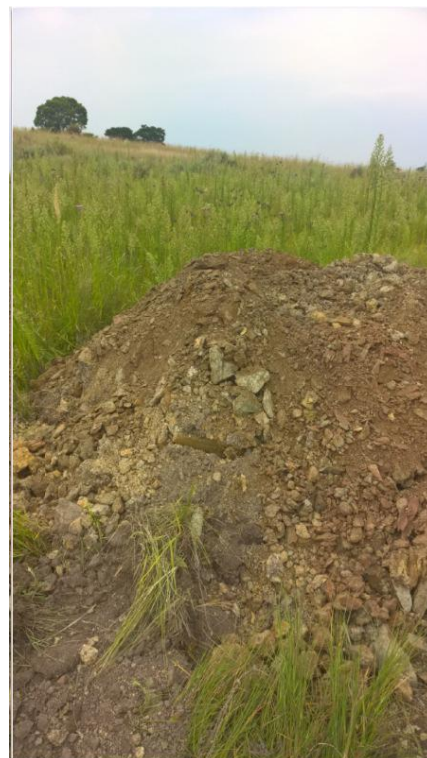
Pale pink speckled black and dark green, evidently fissile, silty sand through very soft rock.

This soil horizon was found to be relatively thick in the vicinity of the quarry - possibly due to impeded groundwater flow - where its base depth was not proven, and the profile contains a significant volume of small, spheroidally weathered, diabase boulders.

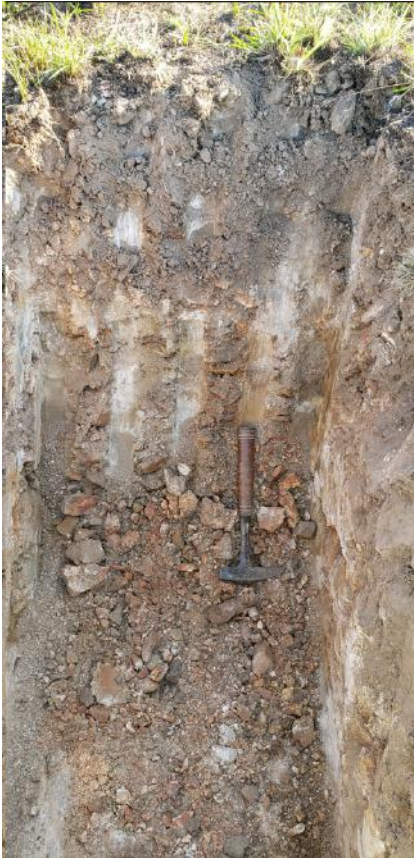
Shallow pegmatite-rich granite rockhead exposed in TP04

Shallow bedrock of very soft through soft rock quality is found to be fairly prevalent in the western slope of the site - as highlighted in Zone 3 (Figure 4, Appendix A), occurring within both the granite (photos overleaf) and the diabase zones.

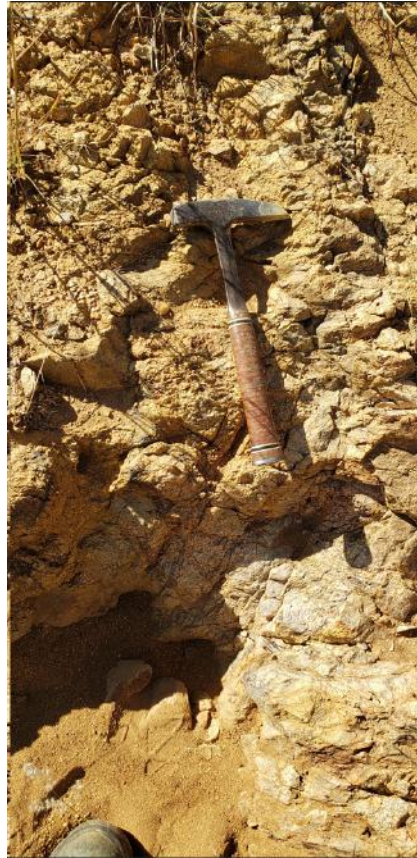
Exposed granite sub-outcrop in the quarry at TP06

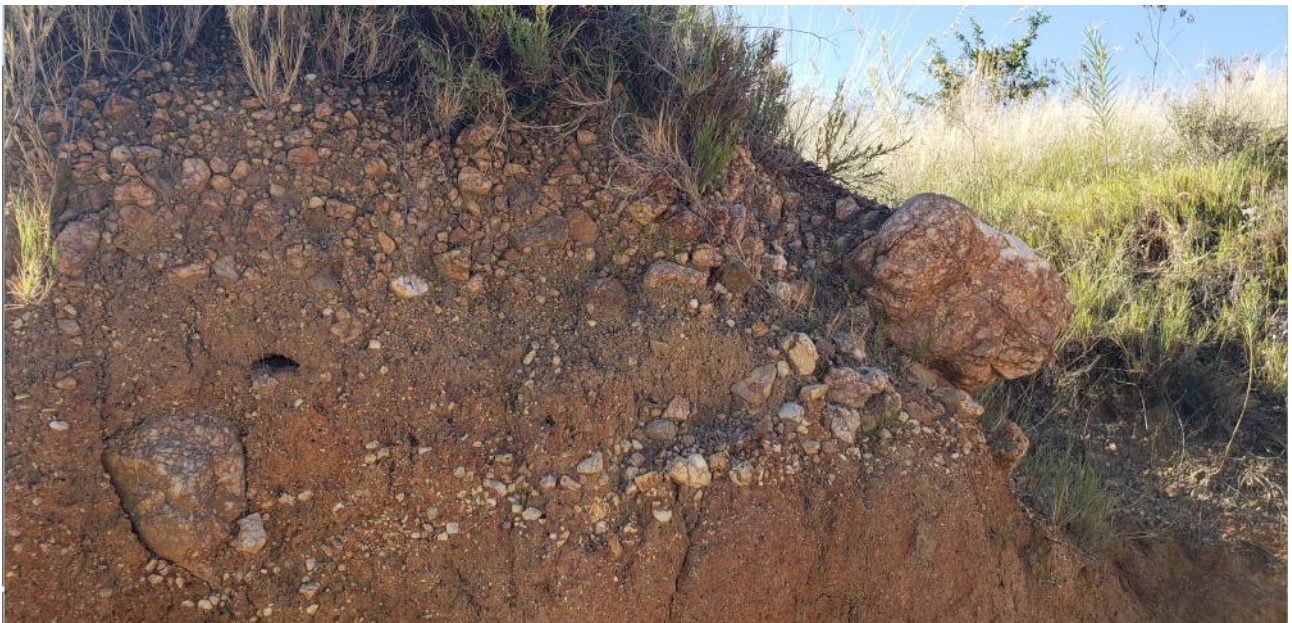
Quartz rock outcrop in the vicinity of TP10

Quartz boulders exposed in the transported zone of the profile, above the residual diabase of TP07, suggest that these may be more discrete than is apparent from ground surface observations at TP10.
