# WETLAND ASSESSMENT

## ERF 5 AND 6, SUNRELLA AGRICULTURAL HOLDINGS

### LANSERIA, GAUTENG

## PRELIMINARY REPORT REV 1

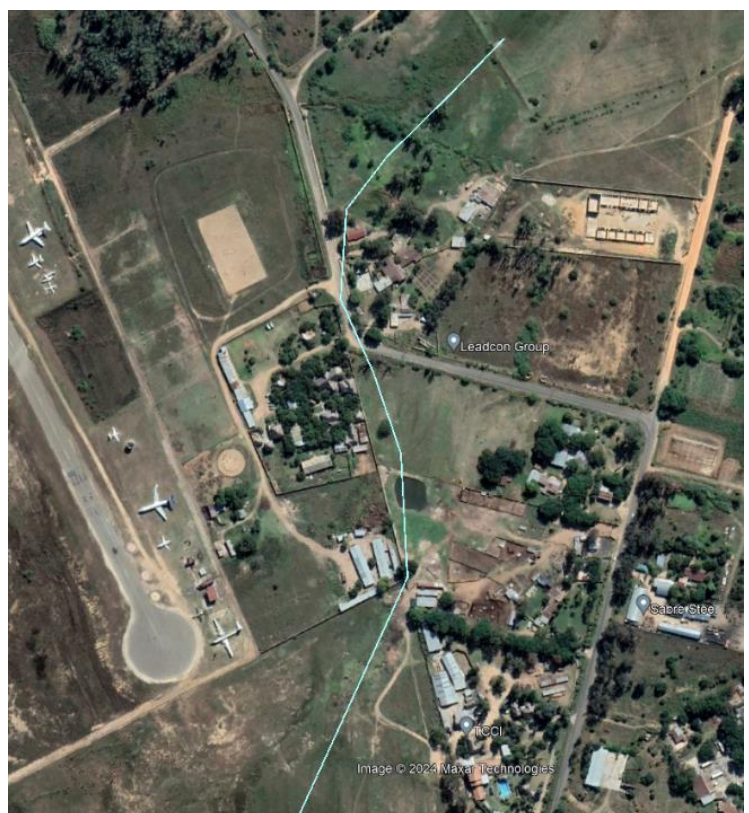
Figure 2. Historical drainage

Prior to the development of the Leachcon Group's earthworks, the drainage of the site was towards the north. **Due to the shallow slope, drainage was in the form of sheet flow with no pronounced drainage line. The soil conditions did not allow for the development of wetlands on the property.**

A dam was constructed on the subject property, within the drainage line, and a trench made to channel the overflow, firstly towards the northwestern corner of the property, and discharge this into the existing water diversion along the road to the Lanseria Permit Office and the houses of the property to the north of the subject site.

Subsequently the dam wall was breached, and a new trench made that diverted the water to the northeastern corner of the subject property where it is flows through a series of holes in the boundary wall and discharged into a concrete channel that runs along the western side of the existing road. The absence of a wetland is confirmed by the investigation of the soil conditions exposed by the excavation.

The absence of a wetland is confirmed by the investigation of the soil conditions exposed by the excavation.

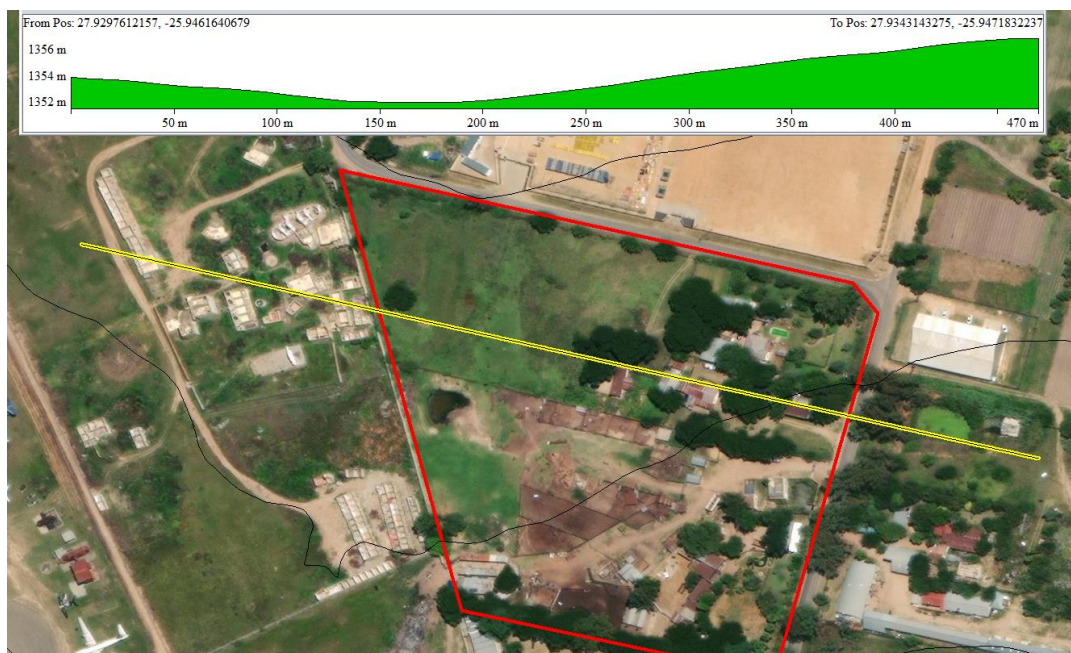
The site slopes north towards the Jukskei River. The site is a narrow, slightly concave drainage system with sheet flow during high rainfall events.

The kraals left small portions with micro indentations that become water saturated following rain events. Lateral water drainage takes place above the solid granite or ferricrete and then emerges again lower in the landscape.

*Figure 3. Section of the site to indicate the general topography.*

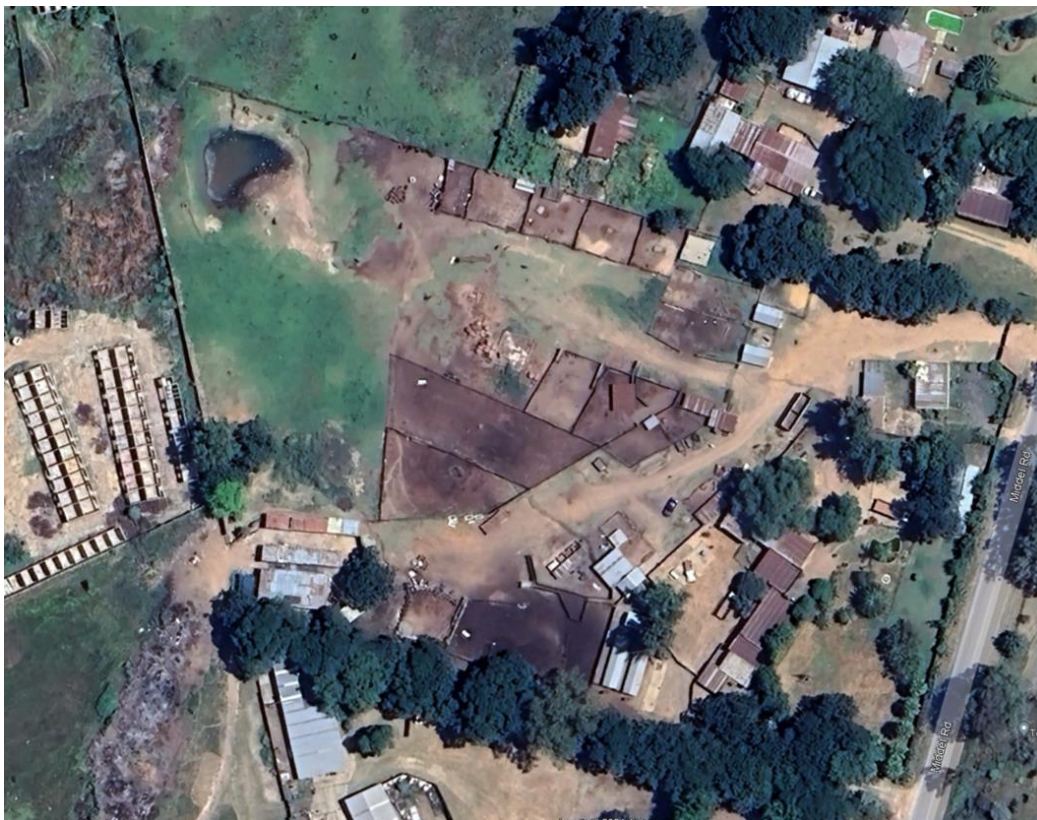
Historical aerial photographs indicate that Stand 5 was used as rearing pens for livestock even prior to 2001. The impervious nature of the soils of the old cattle kraals produces nutrient enriched water that causes weeds and kikuyu to grow uncontrolled on the property.

**Figure 9. Google photo taken in 2018 showing no evidence of drainage channels.**
