# WETLAND STUDY:

## PROPOSED DEVELOPMENT OF LANSERIA ERF 157

## GAUTENG PROVINCE

November 2024 (REV 1)

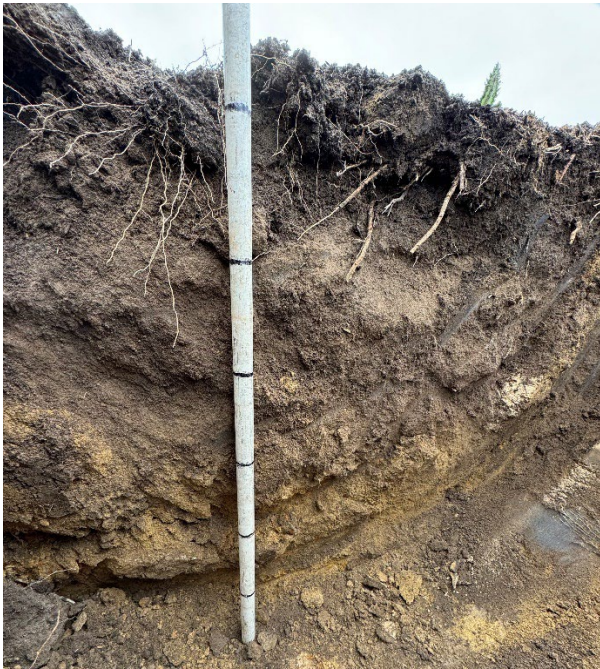
*Photo 1. Dry Glenrosa soil indicated as high sensitivity*

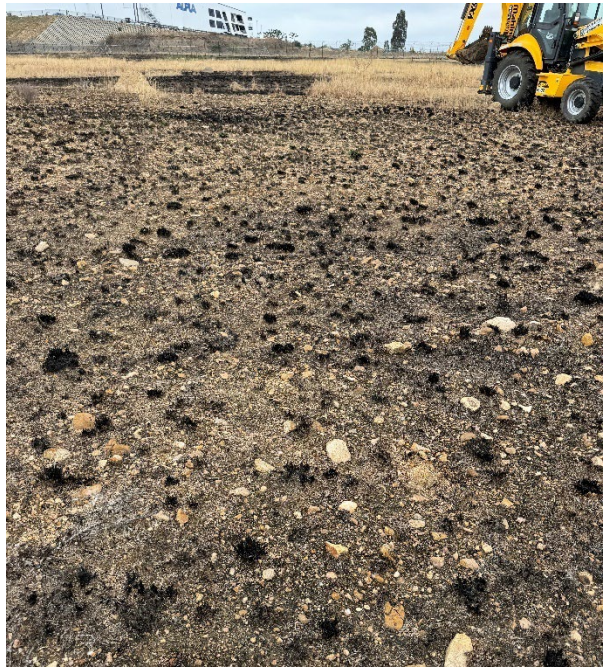
*Photo 2. Dry rocky soil indicated as high sensitivity*

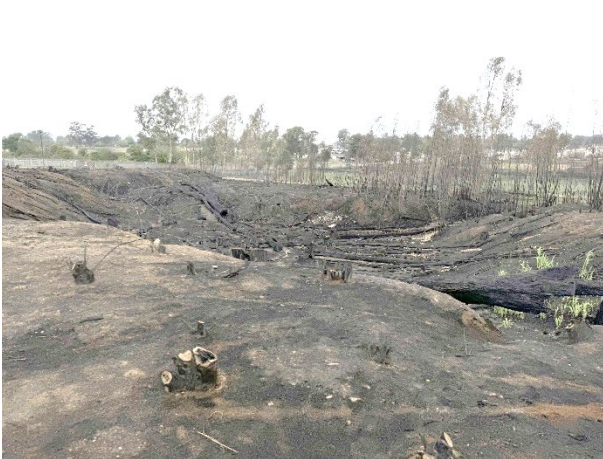
*Photo 3. Stockpiled soil indicated as high sensitivity*

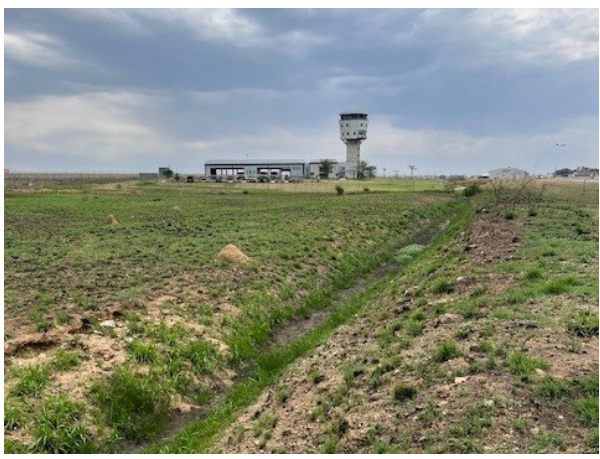
*Photo 4. Constructed stormwater drain*

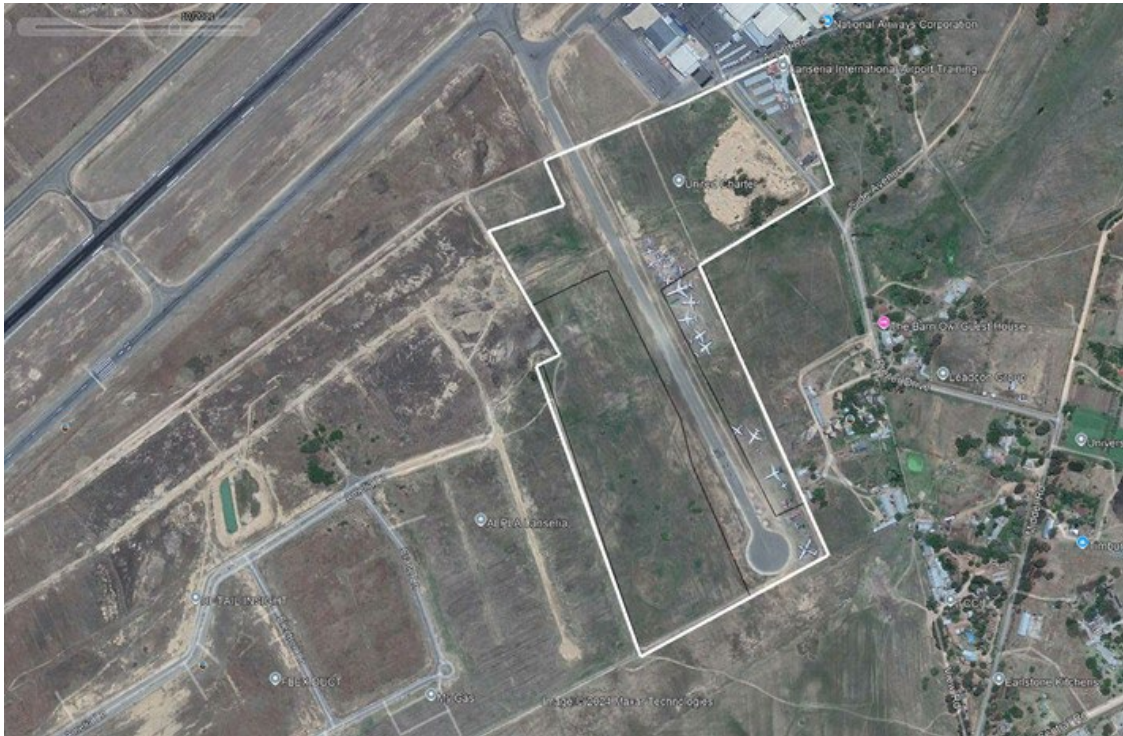
*Figure 6. Google image 2011. Soil was dumped in the northeastern section of the development site*

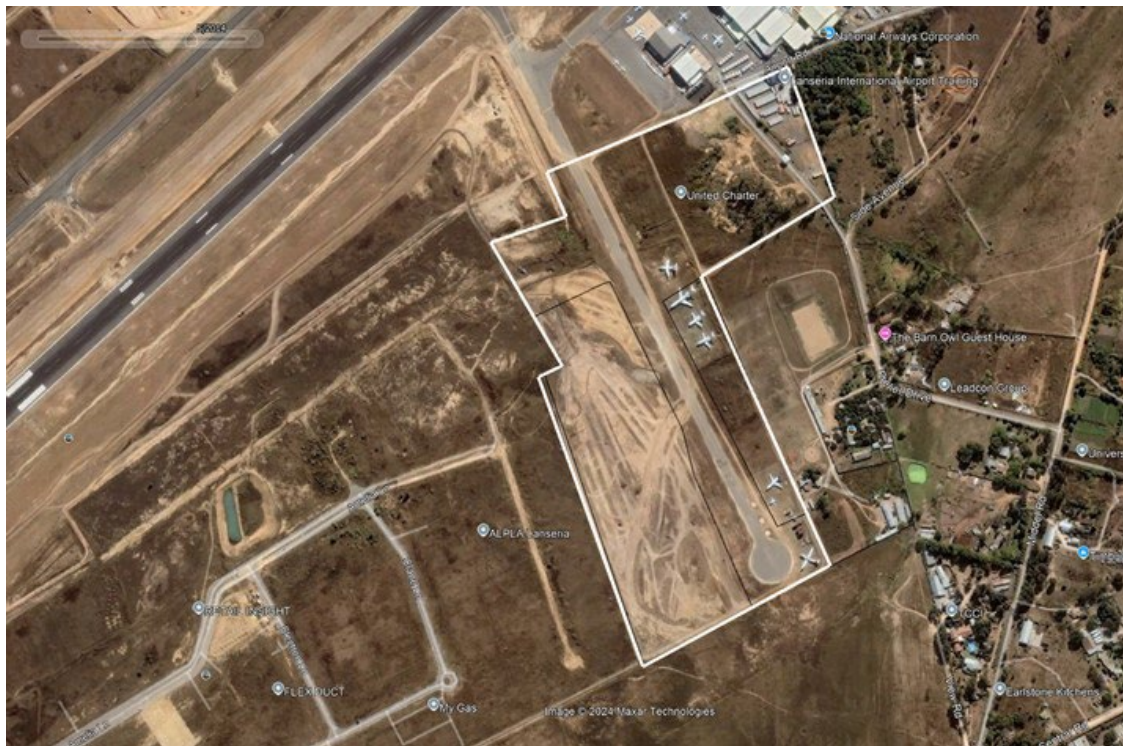
*Figure 7. Google image 2014. The portion of land west of Runway 3 was stripped and the material used for construction purposes.*

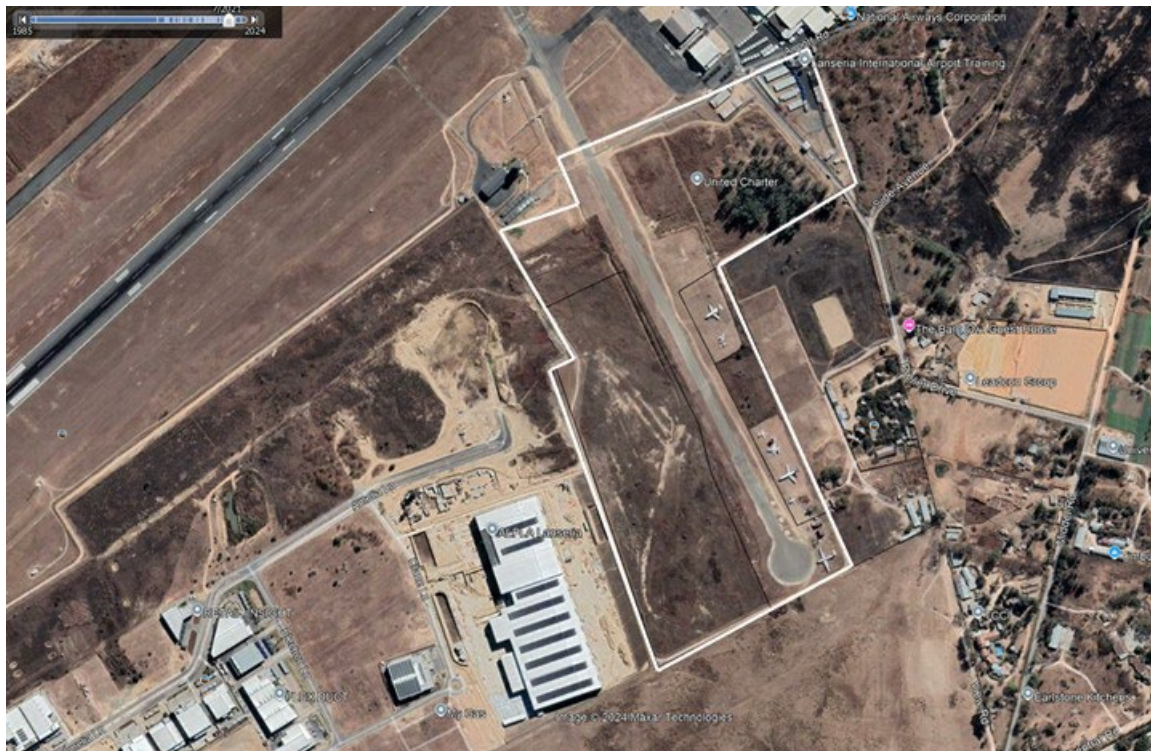
*Figure 8. Google image 2021. Land preparation and construction of the ALPLA Lanseria - Packaging facility.*

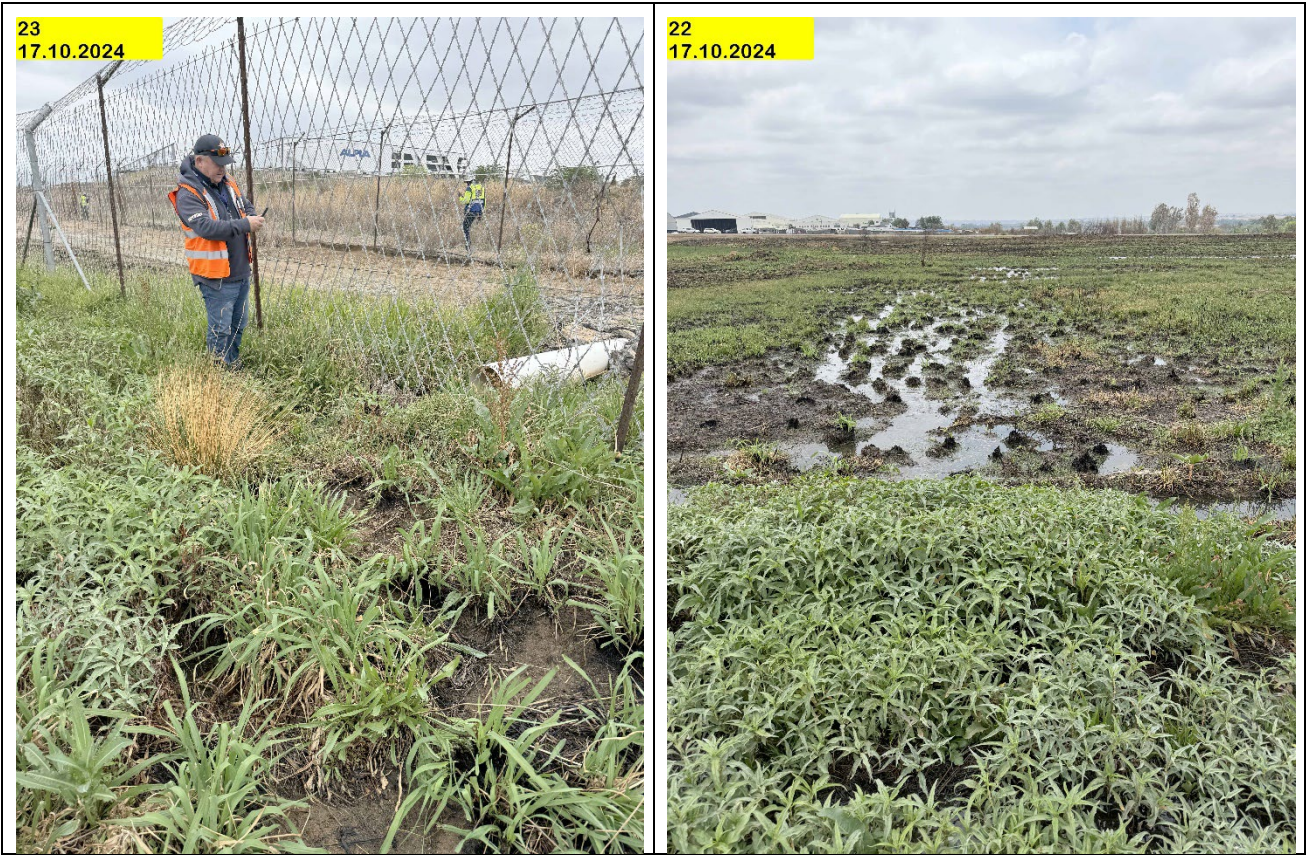
ALPLA Lanseria - Packaging company's stormwater is channelled north towards a storm water attenuation pond from where it is gradually released through a constructed berm by regular placement of 100mm to 300mm drainage pipes.

Photo 5. Storm water drains along the southern boundary

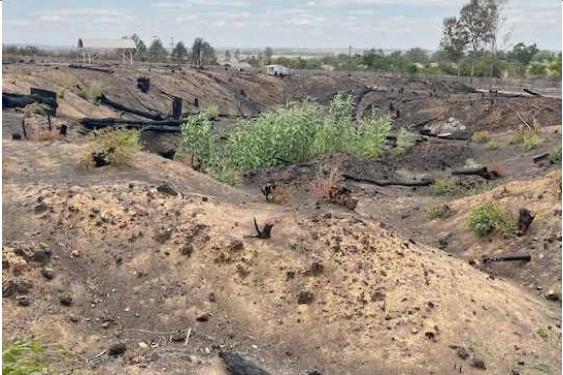
| Unit | Wetland soil | Area (ha) | Description | |
|---|---|---|---|---|
| Exc | No | 1.91 | Excavations / derelict land covered with mainly <i>Eucalyptus</i> trees.<br>Due to the uneven topography, some areas gave rise to saturated soil conditions which allowed wetlands plants to develop. This, however, is not a wetland. | |

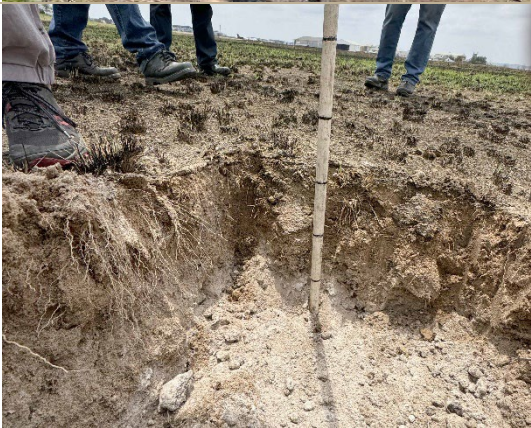
| Unit | Wetland soil | Area (ha) | Description | |
|---|---|---|---|---|
| Gs250 | No | 0.29 | Shallow greyish topsoil that overlies partially weathered granite. Most of the topsoil was stripped in 2014.<br>The topsoil's water holding capacity breached and the profile saturated. Once water no longer infiltrates, surface saturated flow in the layer above the granite or surface flow takes place.<br>The soil shows signs of sheet and gully erosion. | |

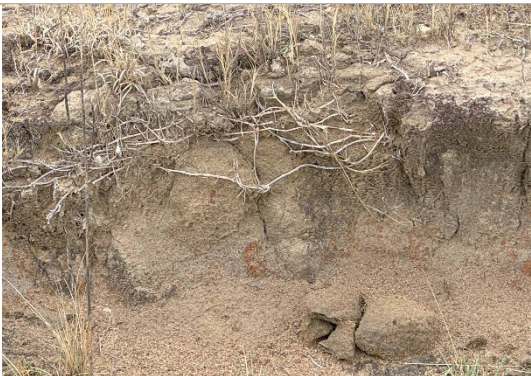
| Unit | Wetland soil | Area (ha) | Description | |
|---|---|---|---|---|
| Gs300 | No | 8.2 | Similar to Gs250, the soil was stripped of soil for construction purposes. However, this soil unit has a dry subsoil with only terrestrial vegetation. | |

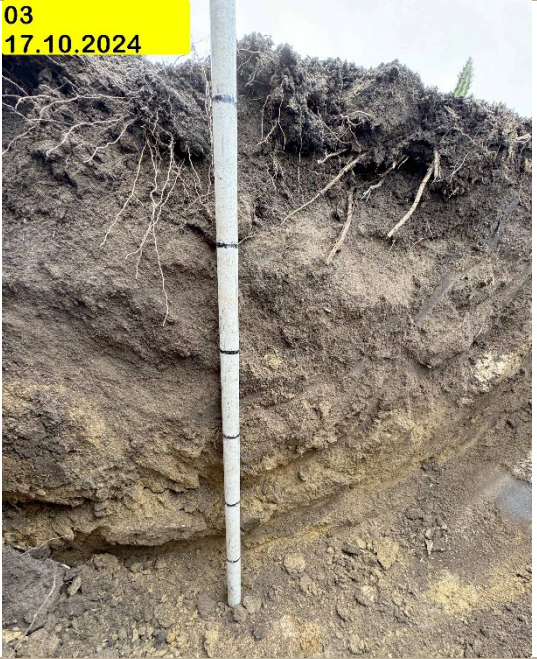
| Gs400 | No | 1.87 | This unit occurs in the northern part of the site, next to the runway. It consists of shallow yellowish-brown topsoil on partially weathered granite. The soil is 400 to 500 mm deep. | <div>03<br/>17.10.2024</div> |

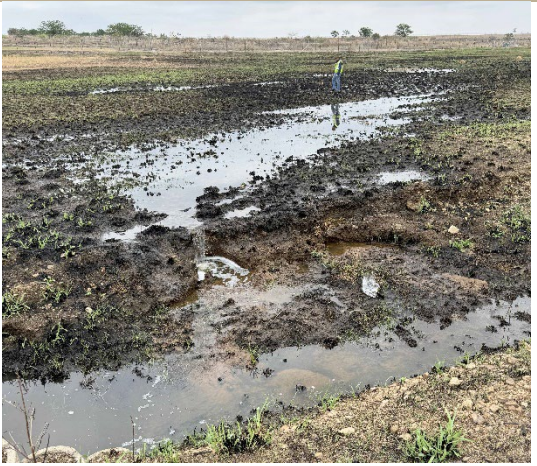
| Lo/Wc | Yes | 1.51 | Profile development has taken place since 2014 and has caused mottling. However, because the soil is shallow and the water holding capacity is low, it rapidly dries out with the result that only facultative wetland species thrive. | |

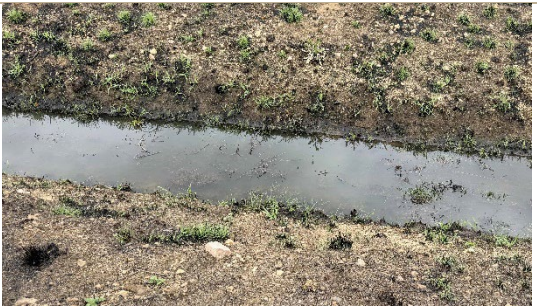
| Wb | No | 2.1 | The runway effectively acts as a cutoff structure. All the water from surface flow to the north of west of the runway is channeled and released through a drain to the part north east of the runway. The channel was full of water during the time of the survey. | |

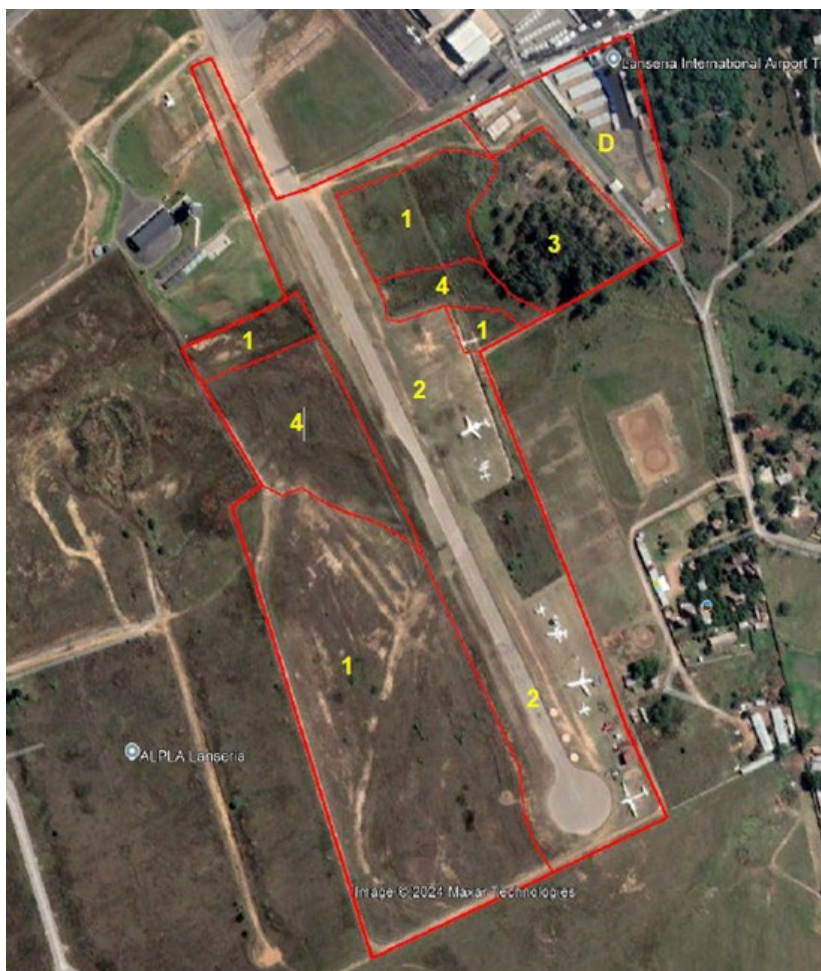
**Vegetation unit 1:** Degraded grassland that comprises the largest part of the study area. In 2014 the area was cleared for construction purposes. This has resulted in pioneer and secondary successional species establishing together with alien invasive trees. The prominence of the grasses *Eragrostis rigidior*, *Hyparrhenia hirta* and *Heteropogon contortus* together with various pioneer grasses and forbs are indicative of the previous degradation.

**Vegetation unit 2:** The Runway grass area includes a runway and where decommissioned airplanes are parked. The area is mowed on a weekly basis and maintained as a lawn to prevent birds from roosting.

**Vegetation unit 3:** This is an Artificial wetland area and is located in the western and eastern sections of the study area. The vegetation includes a mixture of terrestrial and moisture-loving plants. These areas were originally terrestrial land but was modified during the construction of the secondary runway. Stormwater from
