**CONSTRUCTION ENGINEERING GEOTECHNICAL
REPORT FOR IMPACT MINISTRY BUILDING
INFRASTRUCTURES IN JOHANNESBURG, SOUTH
AFRICA.**

Client: IMPACT MINISTRY

Report No.: 103-01-11 July 2011

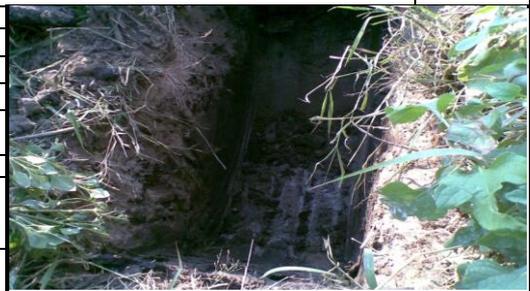
Test Pit Picture

PROJECT: Impact village	TEST PIT: TP4	DATE: 2011 July
SITE: Impact ministry site (JHB)	LOGGED BY: Mashudu Shandukani	
CLIENT: Impact ministry	COORDINATES: 24°56'57.32"S 27°57'45.4"E 1337m	
	MACHINE: TLB CAT

Depth (cm)	Legend	SOIL PROFILE	Sample
10	[Dotted pattern]	Moist to wet, black, soft to firm, intact, silty Clay with Ferricrete nodules of Quartzite, Colluvial.	
20			
30			
40			
50			
60			
70			
80			
90			
100			
110			
120			
130			
140			
150			
160			
170			
180			
190			
200			
210	[Dotted pattern]	Whitish, moderately to slightly weathered, medium jointing, medium grained, hard rock. Quartzite	
220			
230			
240			
250			
260			
270			
280			
290			
300	[Symbol: ط]		
310			
320			
330			
		Notes: Machine refusal at 2.7m. No water seepage observed.
